Manhole Inspection Summary

Manhole # S11AA1011MH

Insp Date: **7/11/07 10:25 AM**

Location Address: **3241 DORITHAN AVE**

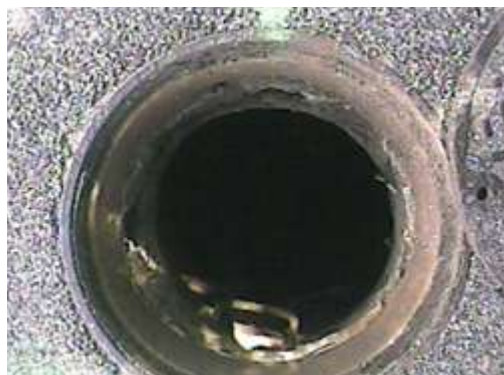
Top View

FRAME OFFSET

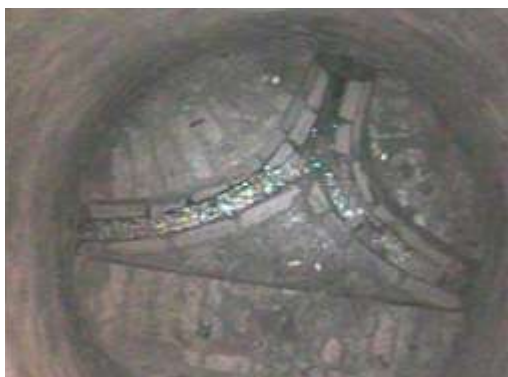
Top View

FRAME OFFSET

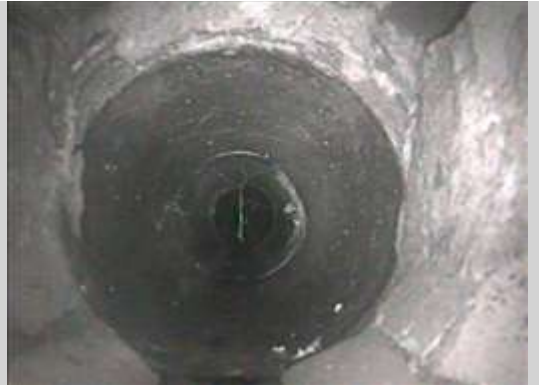
12 O'Clock Outflow

8 in. Circular Gravity Sewer
Pipe Out @ 12 O'Clock

Pipe Material: **Clay** ☐ Pipe Lined

Invert Depth: **8.07** (ft.) Flow Characteristics: **Slow**

Deposits: ☒ None ☐ Mud ☐ Sludge ☐ Debris ☐ Grease

Infiltration: **None** Pipe Seal Cond: **Sound**

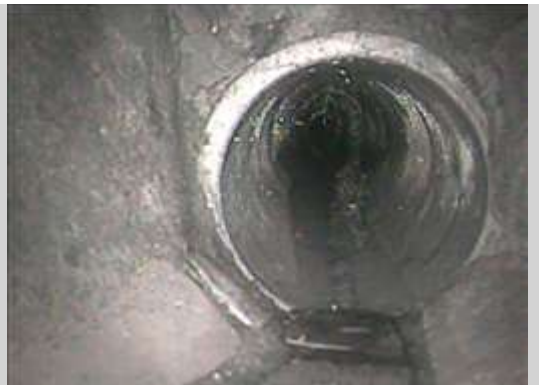
3 O'Clock Inflow

6 in. Circular Gravity Sewer
Pipe In @ 3 O'Clock

Pipe Material: **Clay** ☐ Pipe Lined

Invert Depth: **7.88** (ft.) Flow Characteristics: **Slow**

Deposits: ☒ None ☐ Mud ☐ Sludge ☐ Debris ☐ Grease

Infiltration: **None** Pipe Seal Cond: **Sound**

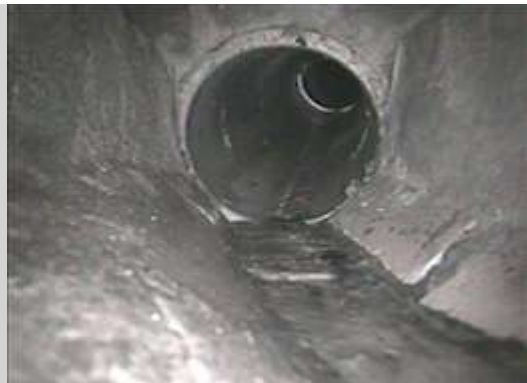
9 O'Clock Inflow

6 in. Circular Gravity Sewer
Pipe In @ 9 O'Clock

Pipe Material: **Clay** ☐ Pipe Lined

Invert Depth: **7.93** (ft.) Flow Characteristics: **Slow**

Deposits: ☒ None ☐ Mud ☐ Sludge ☐ Debris ☐ Grease

Infiltration: **None**

Pipe Seal Cond: **Sound**
